**Reconnaissance Following the October 15th, 2006
Earthquakes on the Island of Hawai'i**

**UNIVERSITY OF HAWAII
COLLEGE OF ENGINEERING**

Research Report UHM/CEE/06-07

October 26, 2006

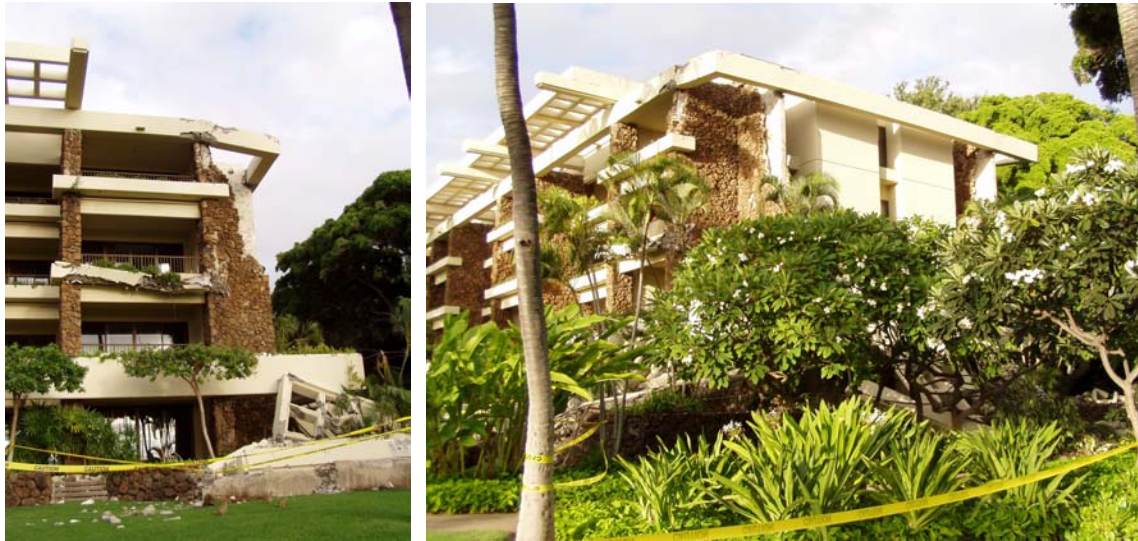
The Mauna Kea Hotel is located on the shoreline just 11 miles from the Kiholo Bay earthquake epicenter. A reinforced concrete trellis structure above the South wing of the hotel collapsed as shown in Figure 8. Damage to a balcony below this structure was probably the result of impact from falling debris (Figure 9). This failure is attributed to combined vertical and horizontal ground shaking causing separation of the precast trellis elements from the supporting cast-in-situ cantilever beams. Fortunately, no injuries resulted from this collapse.

Figure 8: Collapse of concrete trellis frame at Mauna Kea Hotel (B1).

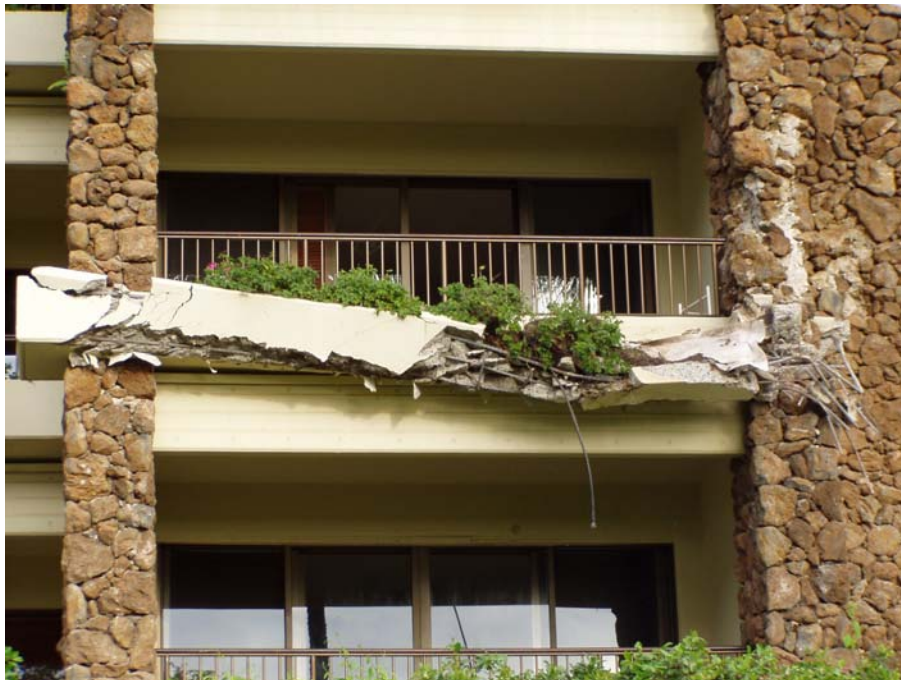
Figure 9: Damage to balcony due to impact from falling debris (B1).

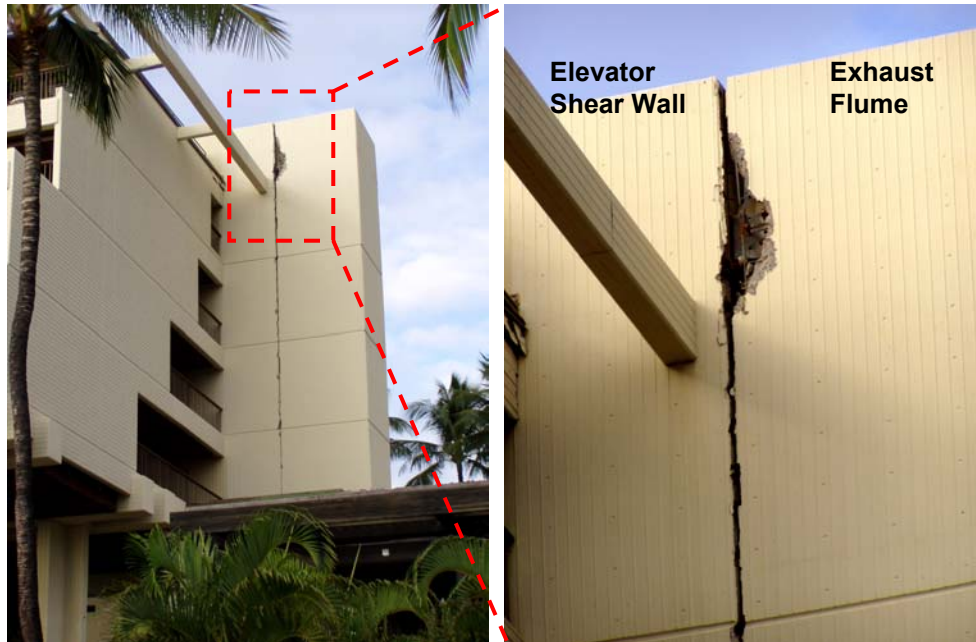
Figure 10 and Figure 11 show significant damage to the concrete surrounding two connector plates between a precast exhaust flume and an elevator shear wall. The U-shaped exhaust flume was added to the South side of the existing shear wall as part of a hotel expansion. The majority of the hotel is still operational.

Figure 10: Damage to concrete flume at connector plate – Makai (Ocean) side (B1).

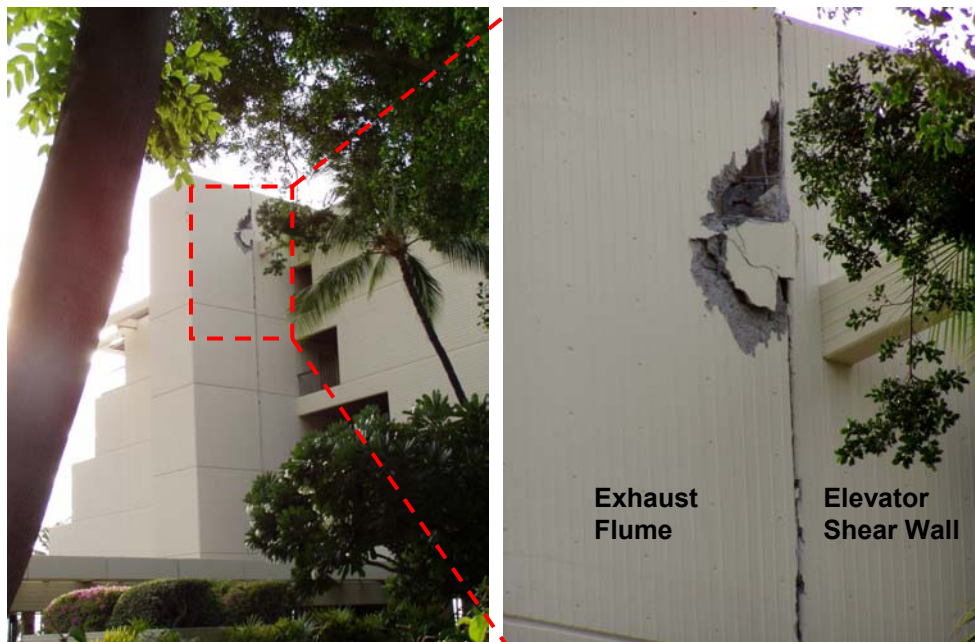
Figure 11: Damage to concrete flume at connector plate – Mauka (Mountain) side (B1).

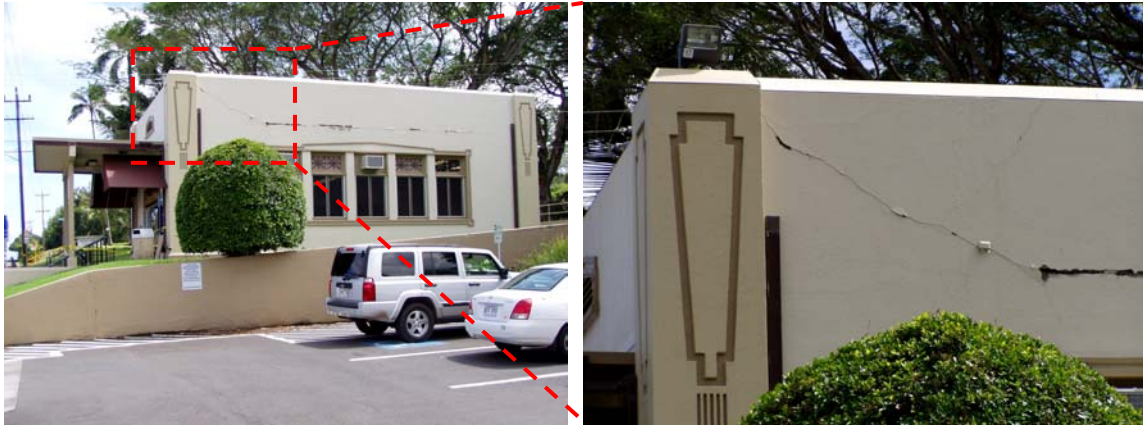
The reinforced concrete walls of this single-story bank building support timber roof trusses spanning between the side walls. The ends of the roof trusses are pocketed into the side walls. Horizontal cracks developed at the level of these roof truss pockets and diagonal cracks occurred at the buildings corners (Figure 12). Lack of adequate diaphragm action at the roof level is thought to have allowed significant out-of-plane

movement of the side walls (personal communication with Gary Chock). The bank is closed until repairs can be made.

Figure 12: Horizontal and diagonal cracks in concrete walls of Bank of Hawaii in Kapaau, near Hawi (B2).

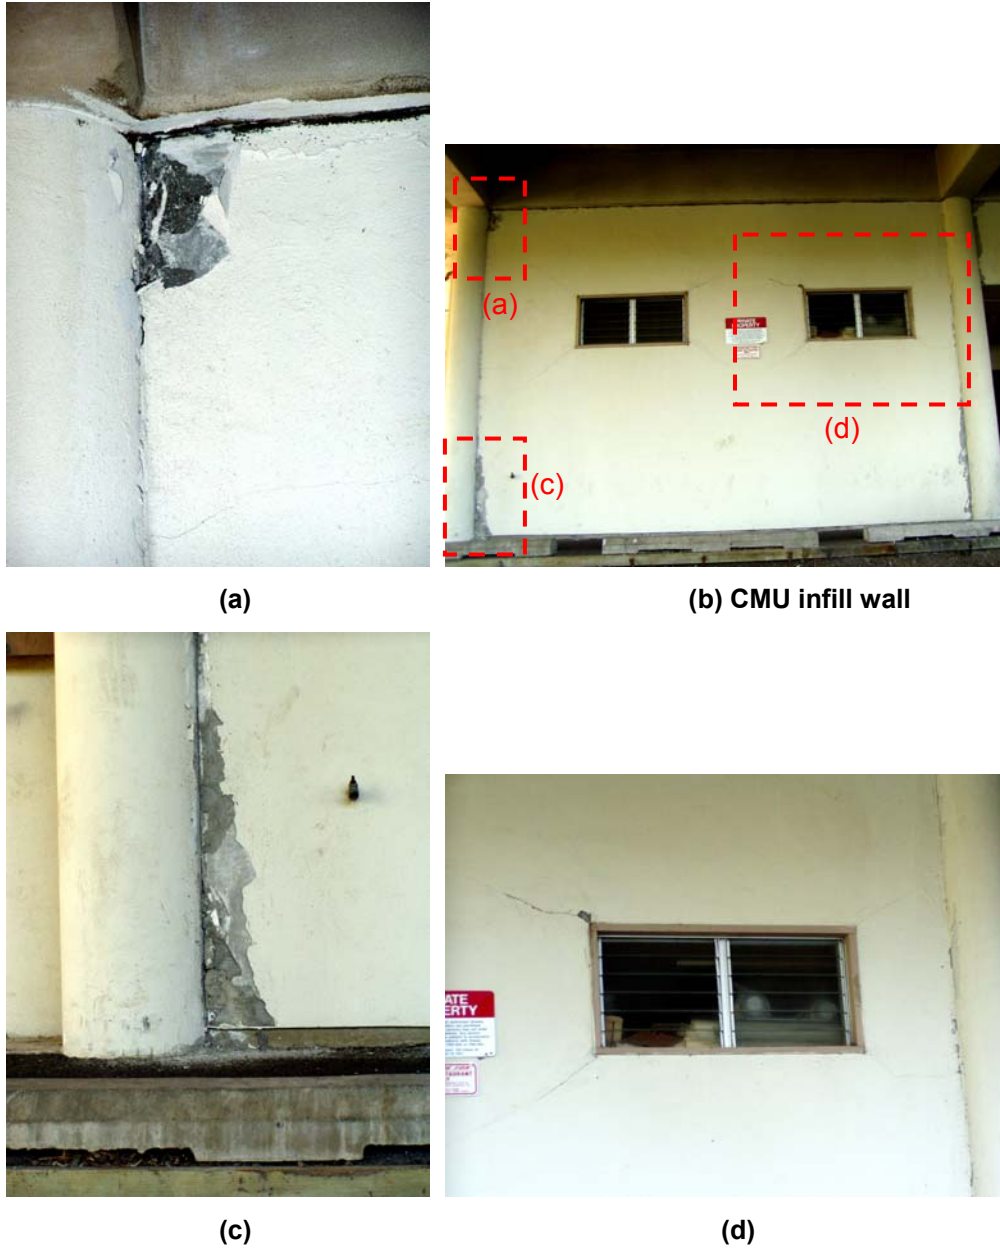
Figure 14: Damage to CMU infill wall due to flexibility of surrounding frame (B3).

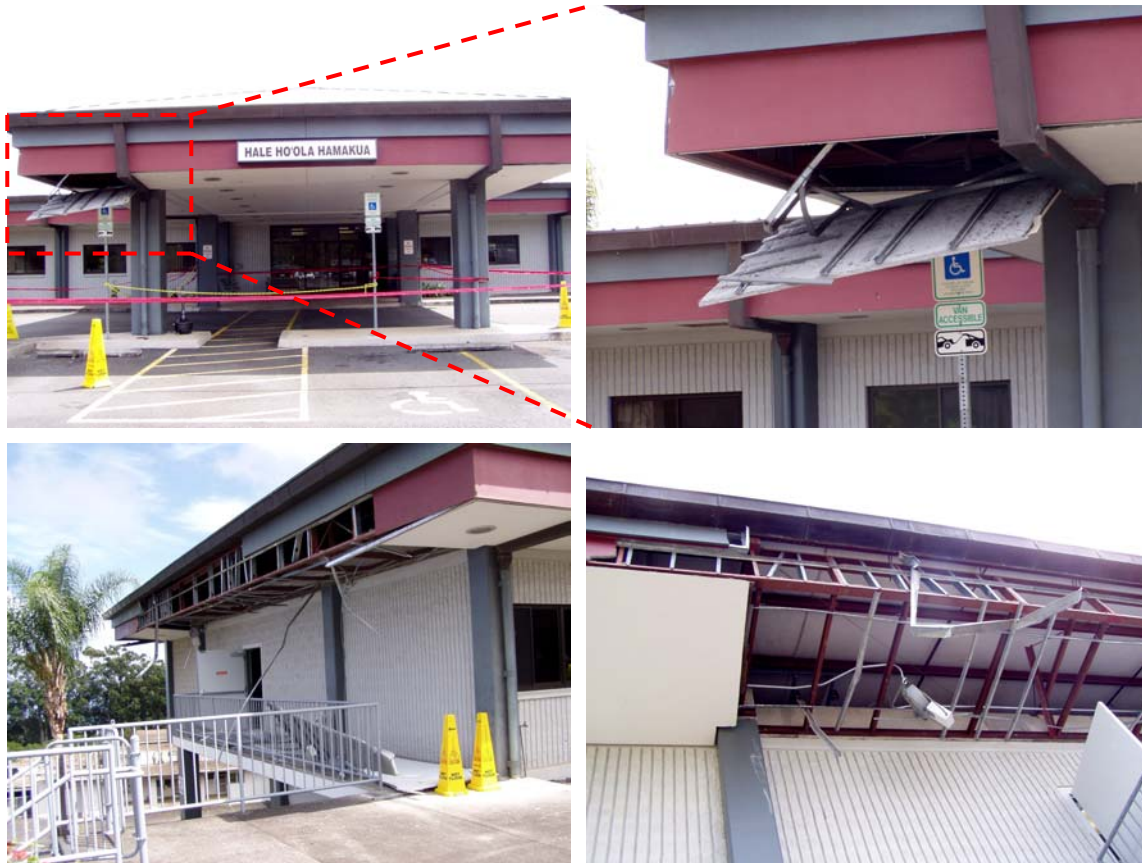
The Hale Ho'ola Hamakua medical facility in Honokaa suffered non-structural damage in the form of fallen stucco ceilings under the exterior roof eaves (Figure 15). Interior ceiling panels were also observed to have fallen in the lobby area. No structural damage was evident during our inspection of the building.

Figure 15: Damage to exterior stucco ceilings at Hale Ho'ola Hamakua medical facility in Honokaa (B4).

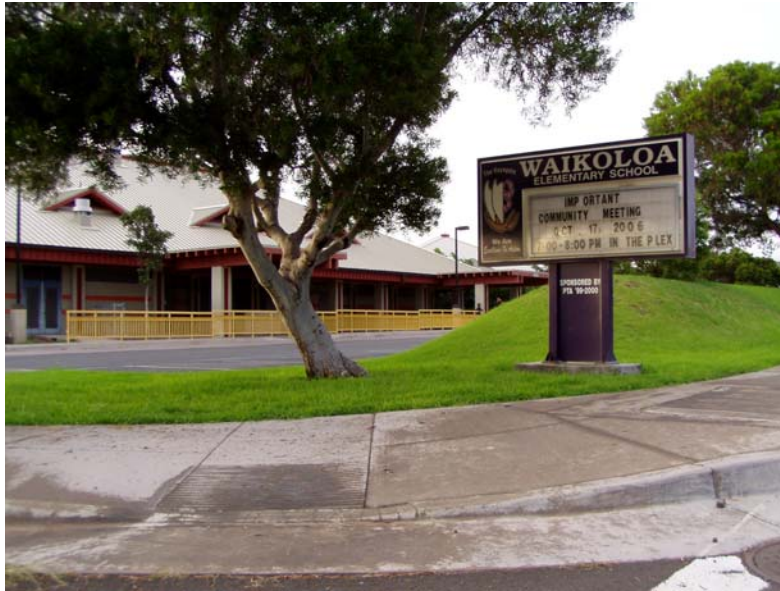
Along with a number of schools in Waimea and Honokaa, the elementary school in Waikaloa suffered considerable non-structural damage (Figure 16). Many classrooms remain closed at the time of writing this report because of fallen ceilings, light fixtures and other non-structural items. Virtually no structural damage was reported at these schools.

Figure 16: Waikaloa Elementary School, closed due to non-structural damage (B6).

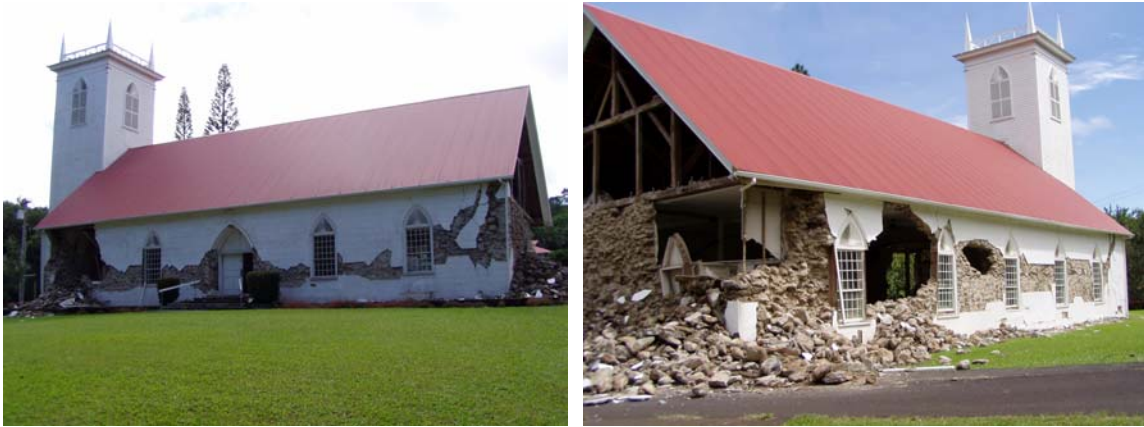
The historic Kalahikiola Church in Hawi, North Kohala, suffered extensive damage to the exterior rock-masonry walls supporting the roof trusses (Figure 17). Total collapse of the roof system appears to have been prevented by a single line of interior columns supporting the center of each roof truss and door and window frames supporting the eaves (Figure 18). The unreinforced rock-masonry walls were grouted with low-strength mortar, similar to many other rock-masonry walls built in the 19th and early 20th centuries (Figure 19). Many of these walls suffered damage in the form of cracking, partial collapse or complete collapse. The timber-framed bell tower appeared to have survived the earthquake with limited damage.

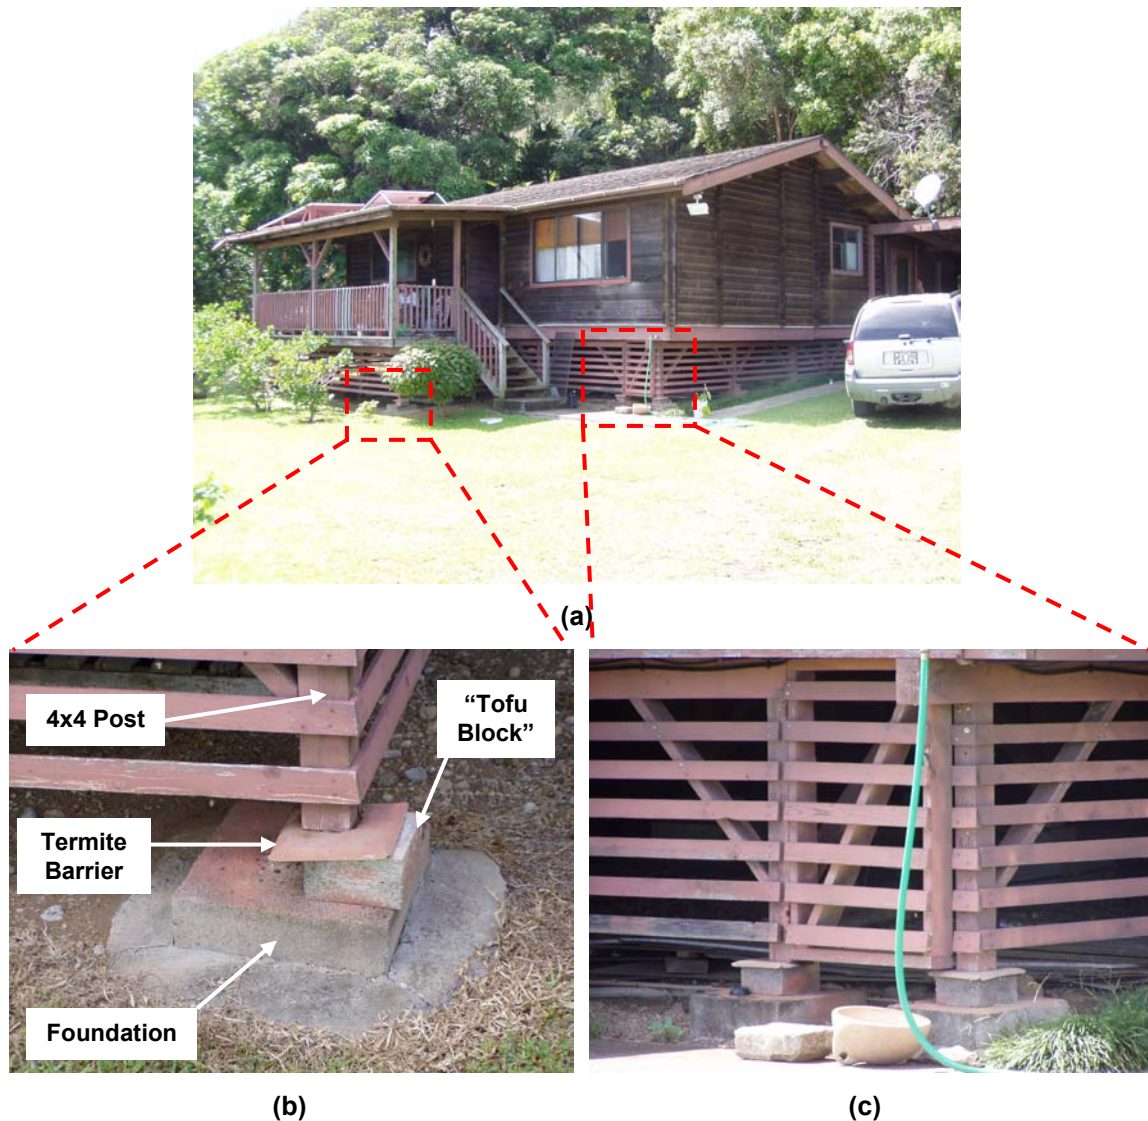
Figure 22 shows a typical single-wall residence near Hawi that has shifted on its foundation, but remains intact.

Figure 22: Typical timber framed residence at Pololu Valley Lookout on pier-and-beam construction (B9).

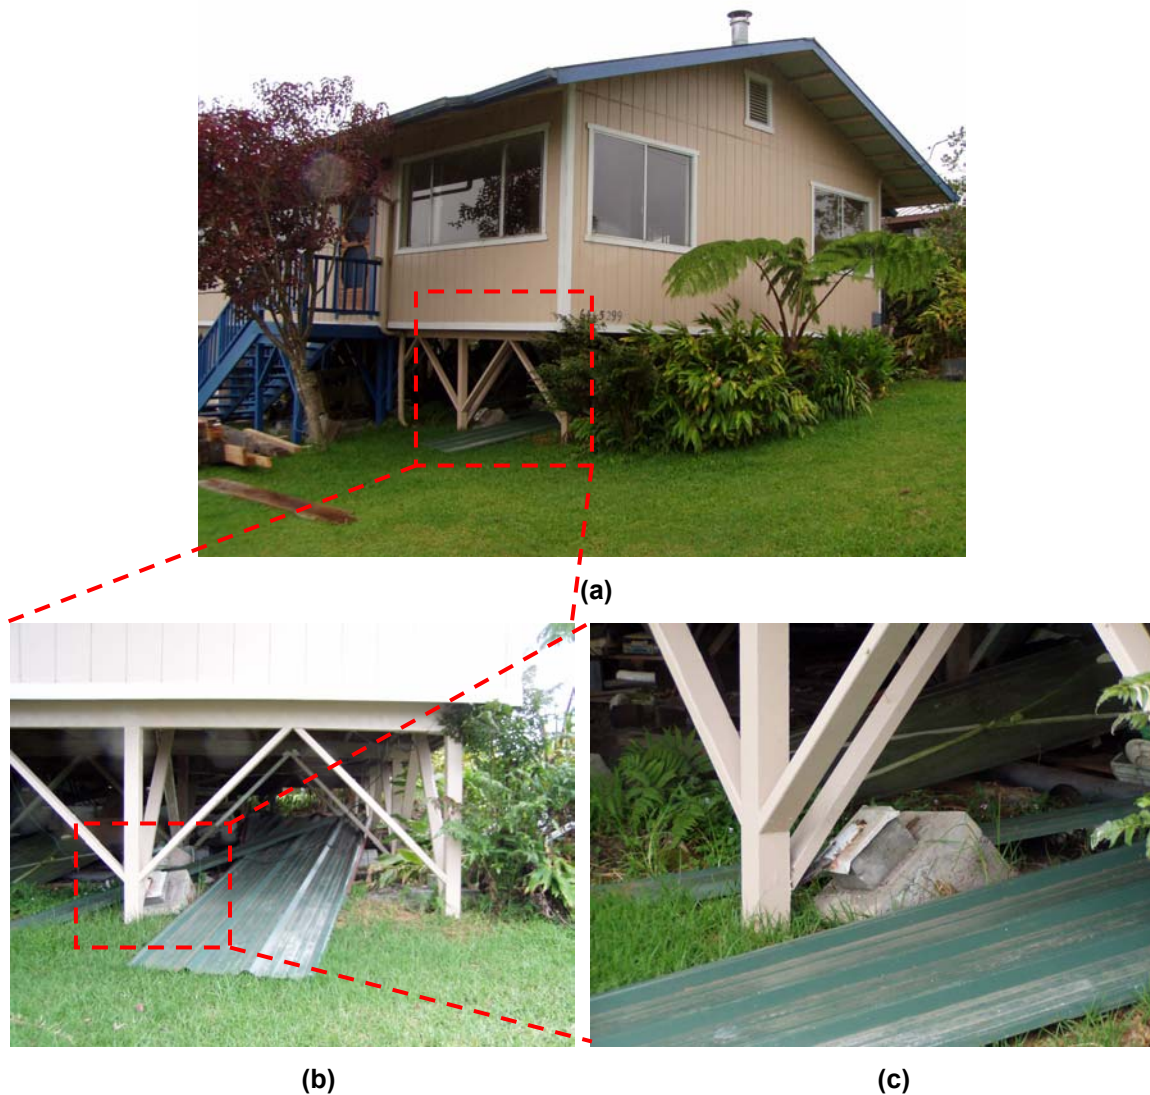
Figure 23 shows a typical single-wall pier-and-beam residence in Waimea that has shifted off its foundation blocks, resulting in damage to the support posts and the roof and wall framing. The owner plans to repair the residence.

Figure 23: Pier-and-Beam residence in Waimea had fallen off its foundation blocks (B10).

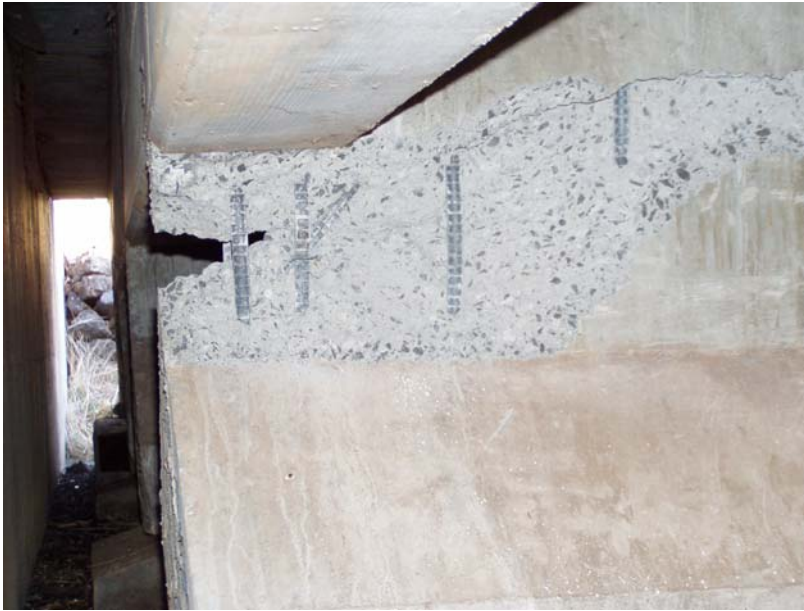
Figure 26: Damage to web of AASHTO girder at abutments (S1).

bridge deck had to transfer through the relatively thin girder webs, resulting in high transverse shear and flexural stresses for which the webs were not adequately designed. The bottom edge of the bridging beams showed a tendency to separate from the webs because of the large transverse inertial forces.

Personal correspondence with the State Bridge Engineer indicated that this bridge was scheduled for a seismic retrofit which was to include extending the bulkhead to the bottom of the girders. This retrofit had already been performed on three similar bridges on the Island of Hawai'i, none of which experienced damage during the earthquakes.

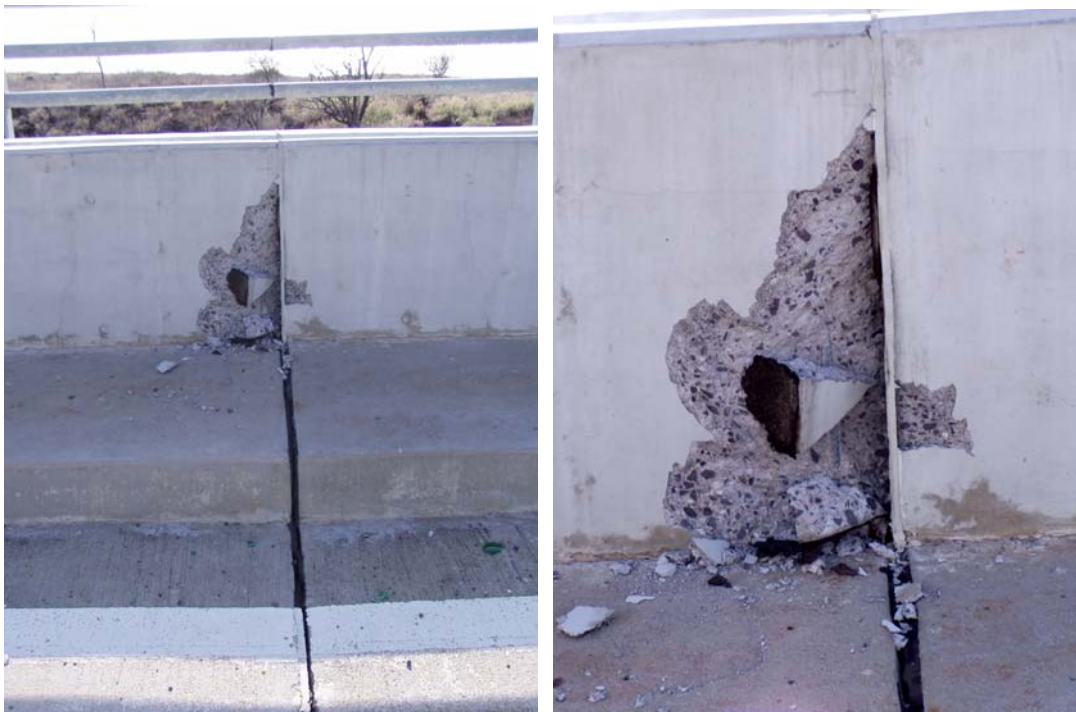
Figure 27: Concrete spalling due to relative movement between bridge segments (S1).

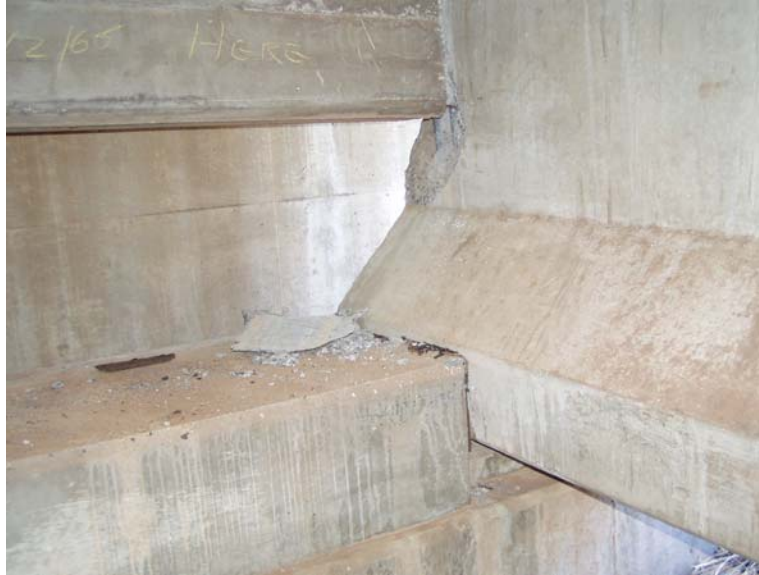
Figure 28: Shear key and bridging beam between AASHTO bridge girders (S1).

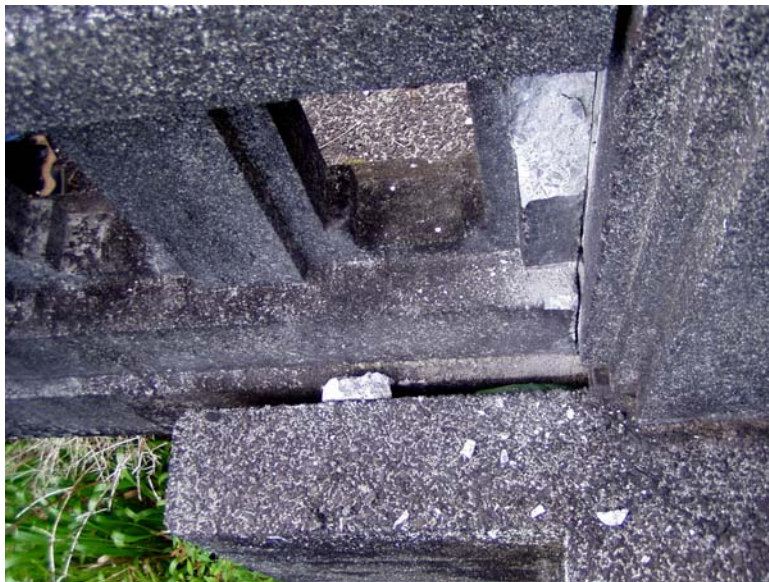
Figure 30: Spalling of guardrail adjacent to North abutment (S2).

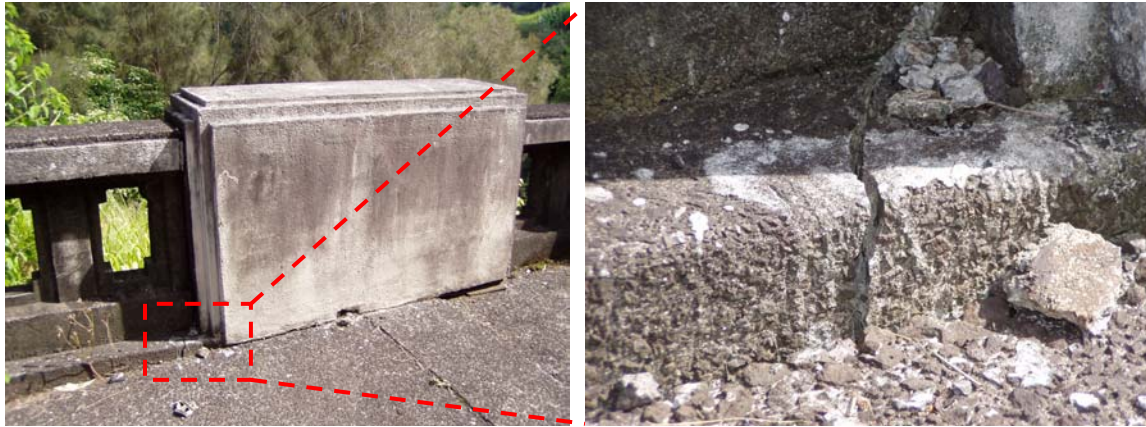
Figure 31: Crack in North abutment of Kealakaha Stream Bridge (S2).

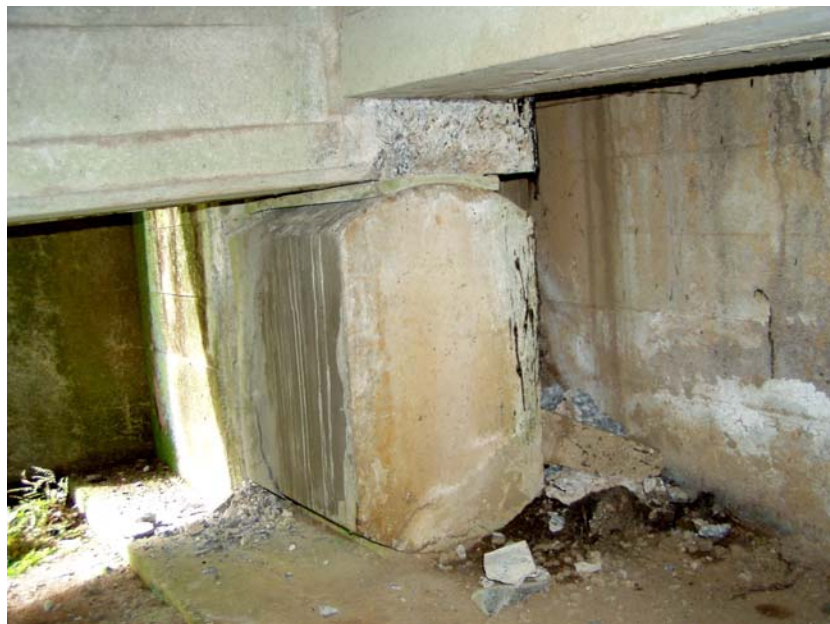
Figure 32: Concrete spalling at girder supports at North abutment (S2).

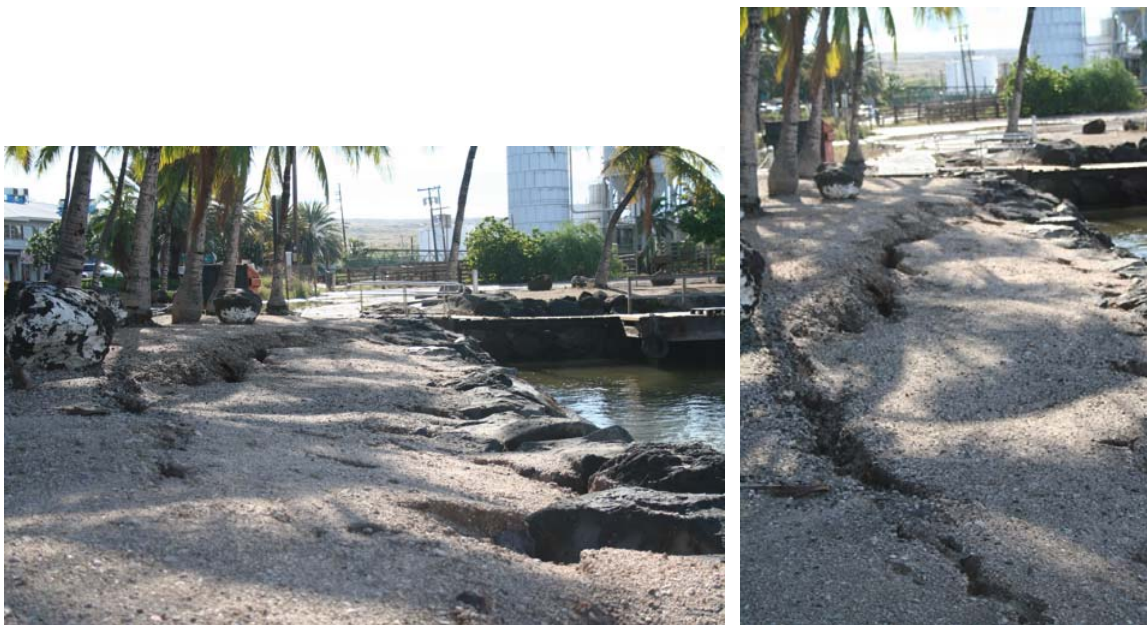
Figure 36: Liquefaction induced settlement and lateral spreading at public marina (H1).

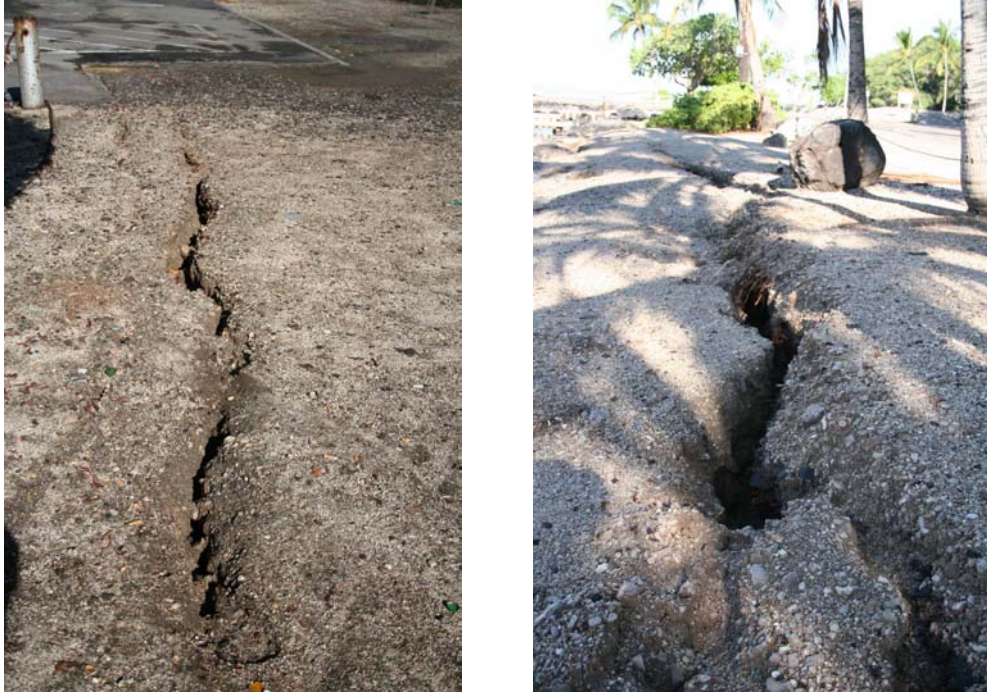
Figure 37: Ground fissures evidencing lateral spreading at public marina (H1).

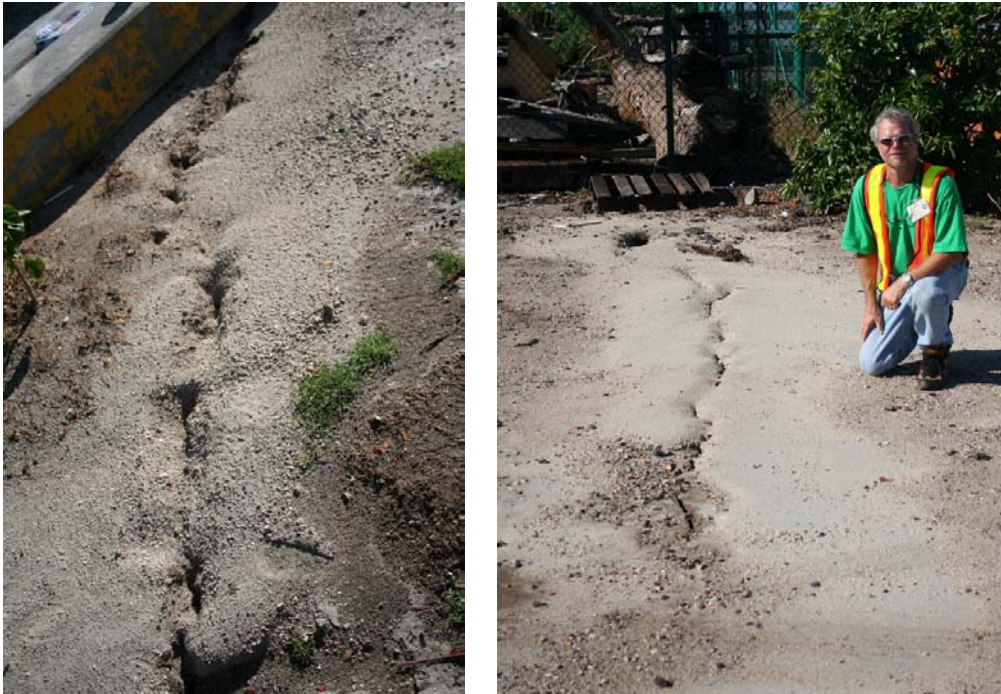
Kawaihae Harbor was visited on both Tuesday and again on Wednesday following Sunday's earthquakes. Clear evidence of liquefaction was observed at Kawaihae Harbor in both the public marina and the commercial port facility. This area is known to contain significant depths of unconsolidated gravelly calcareous sand from adjacent dredging operations. In the public marina area, significant cracks displayed both vertical and lateral displacement of several inches. The shoreline protection provided by 1-3 ft boulders had moved out of alignment with spreading of an area approximately 20 feet from the water's edge. Figure 36 and Figure 37 show cracking and lateral spreading in the public marina. Numerous sand boils were evident in the unpaved parking area and adjacent grassed area up to 50 feet from the water's edge and to elevations of approximately 6 feet above the water level (Figure 38).

Figure 38: Sand boils at Kawaihae Harbor (H1).

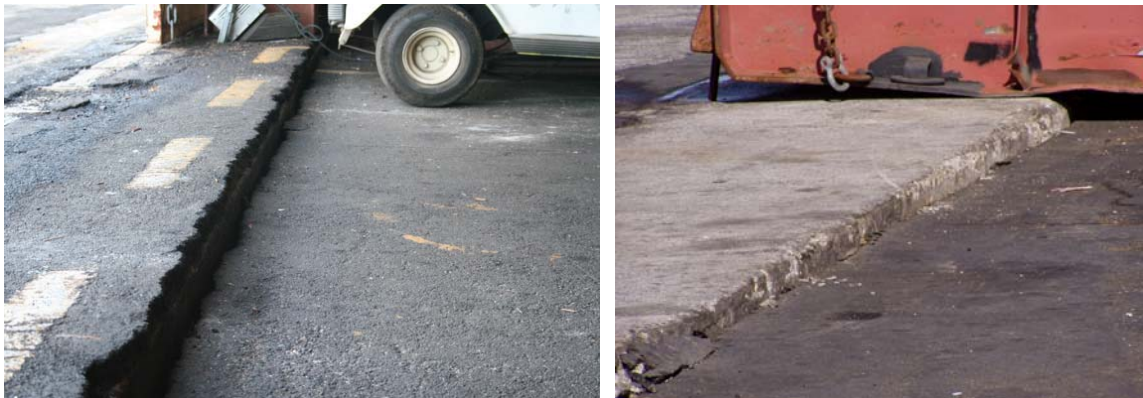
Figure 39: Liquefaction induced settlement at Kawaihae Harbor port facility. Pile supported pier on left, dredged fill beneath pavement on right (H1).

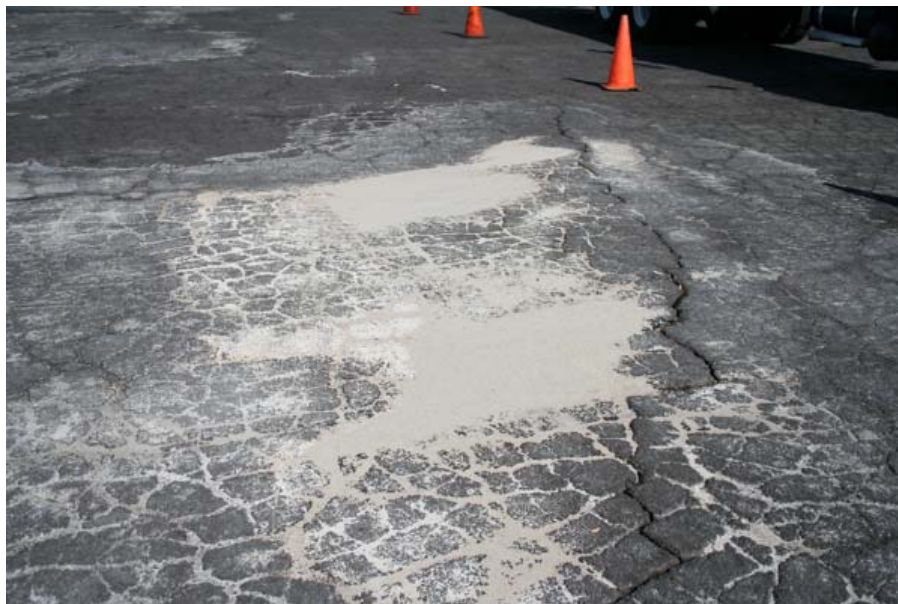
Figure 41: Fine sand ejected through cracks in pavement as soil beneath liquefied at Kawaihae Harbor port facility (H1).

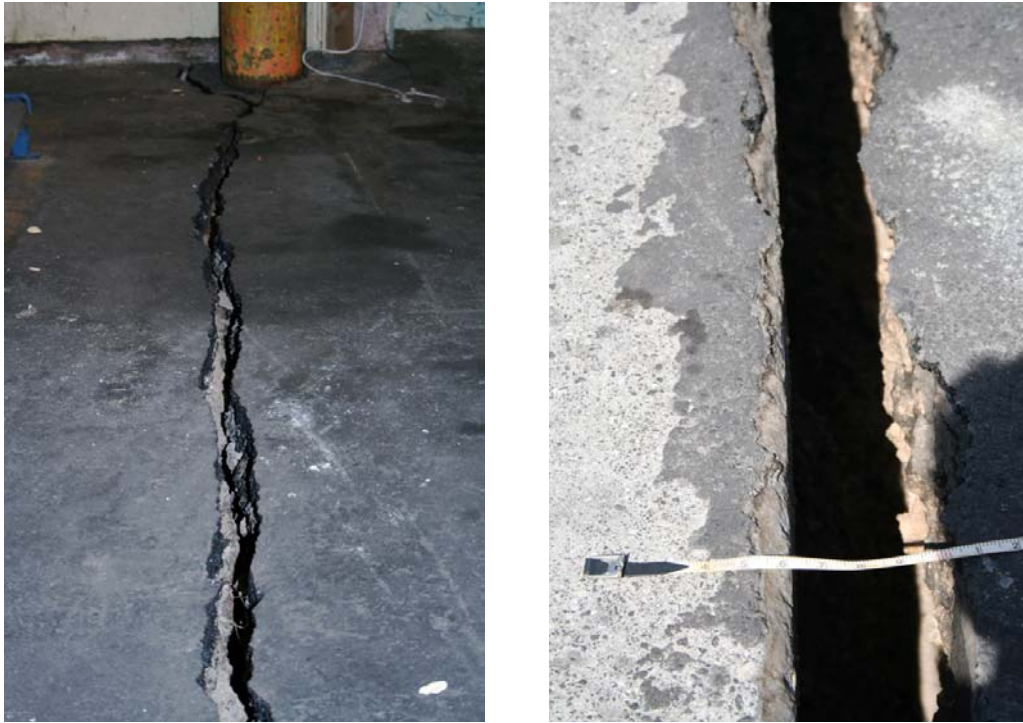
Figure 42: Several-inch gaps formed by relative displacement of pile-supported pier founded in liquefiable soils (H1).

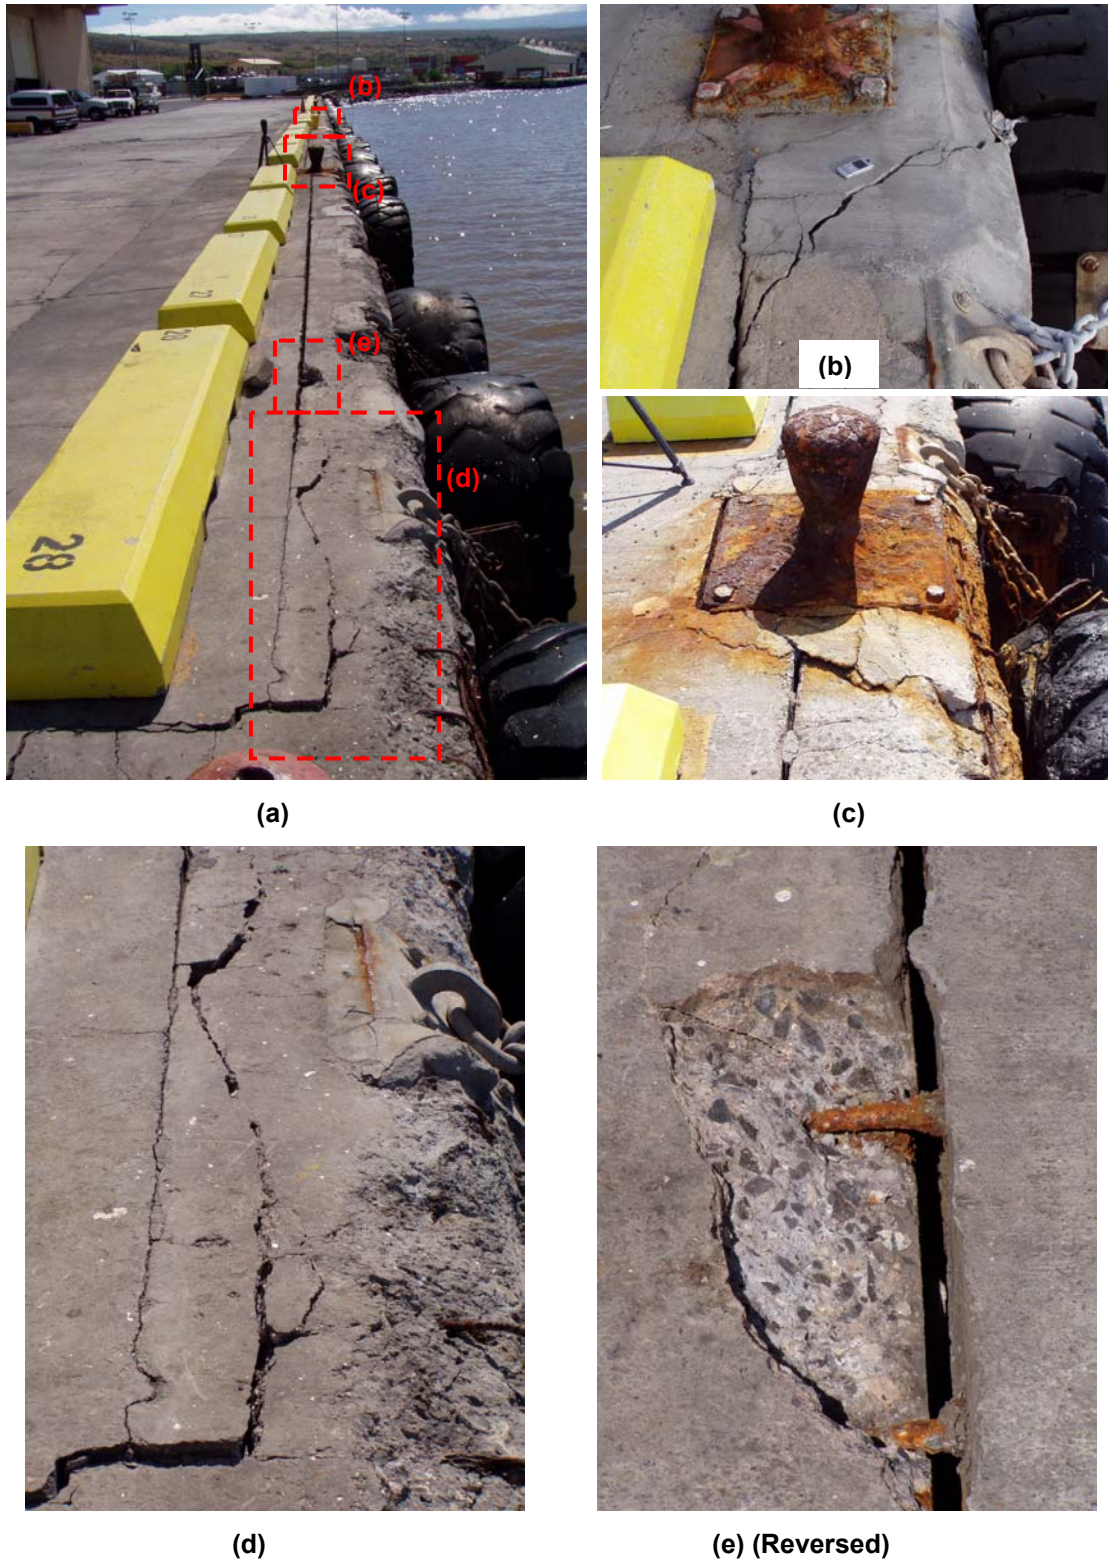
Pier 1 had significant damage as a result of the liquefaction and lateral spreading described earlier. The resulting seaward movement of the pile-supported pier resulted in torsional cracking of the large concrete beam along the edge of the pier. Major torsional and longitudinal cracks were noted in this beam as shown in Figure 43(b), (c) and (d). Separation between the edge beam and concrete approach slab was not controlled by the ineffective and corroded dowel bars shown in Figure 43(e). It is unknown whether there was any damage to the piles supporting the pier and this edge beam.

Figure 43: Torsional cracking in edge beam at Kawaihae Harbor Pier 1 (H1).

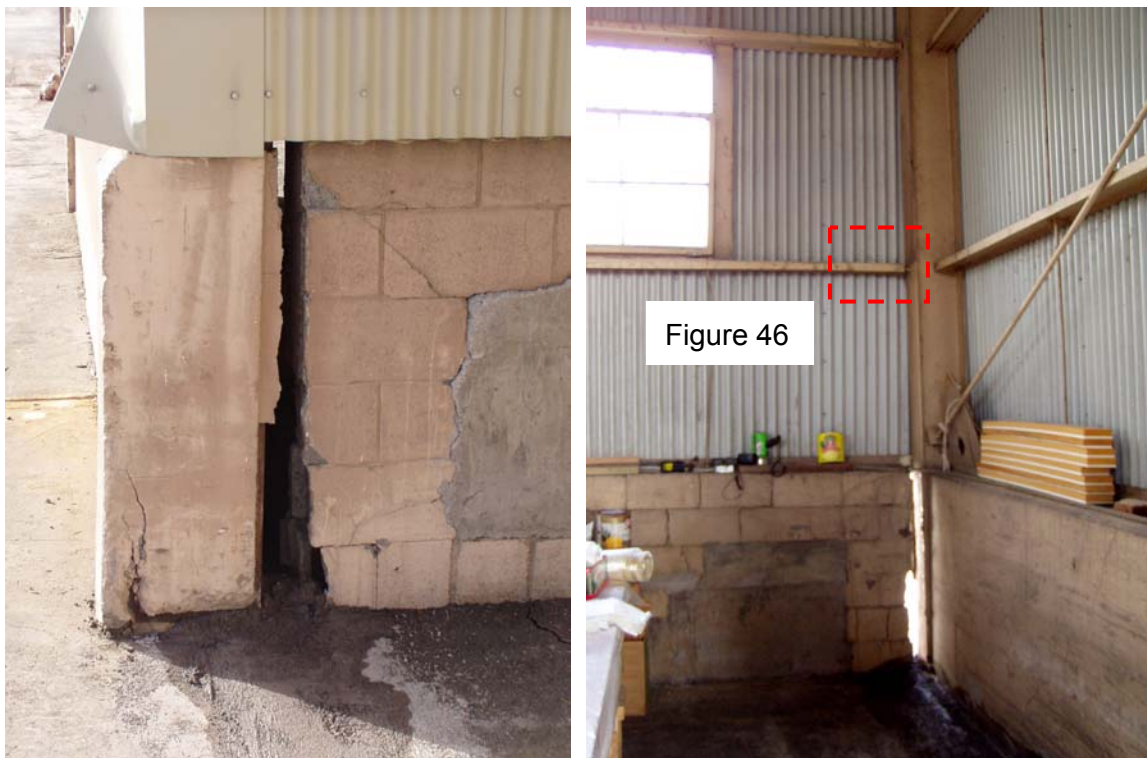
Three warehouses on Piers 1 and 2 are constructed of pre-manufactured metal frames with sheet metal cladding (Figure 44). Since the seaward columns are all supported on the concrete piers, while the landward columns are supported on foundations in the fill material below the approach paving, the metal frames had spread to accommodate the lateral movement of the piers. Figure 45 shows the resulting opening in the unreinforced concrete masonry unit (CMU) wall at the South side of one of these warehouses on Pier 1. The interior view of this warehouse shows that the column lateral movement resulted in shear failure of the two bolts securing the end of the first horizontal girt (Figure 46).

Figure 45: Separation in CMU wall at corner of warehouse (outside and inside views) (H1).

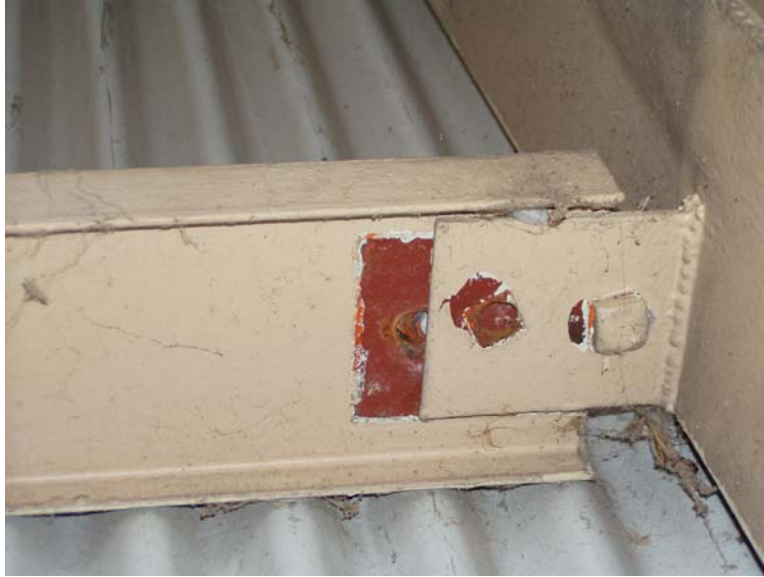
Figure 46: Shear failure of bolts securing girt to corner column (H1).

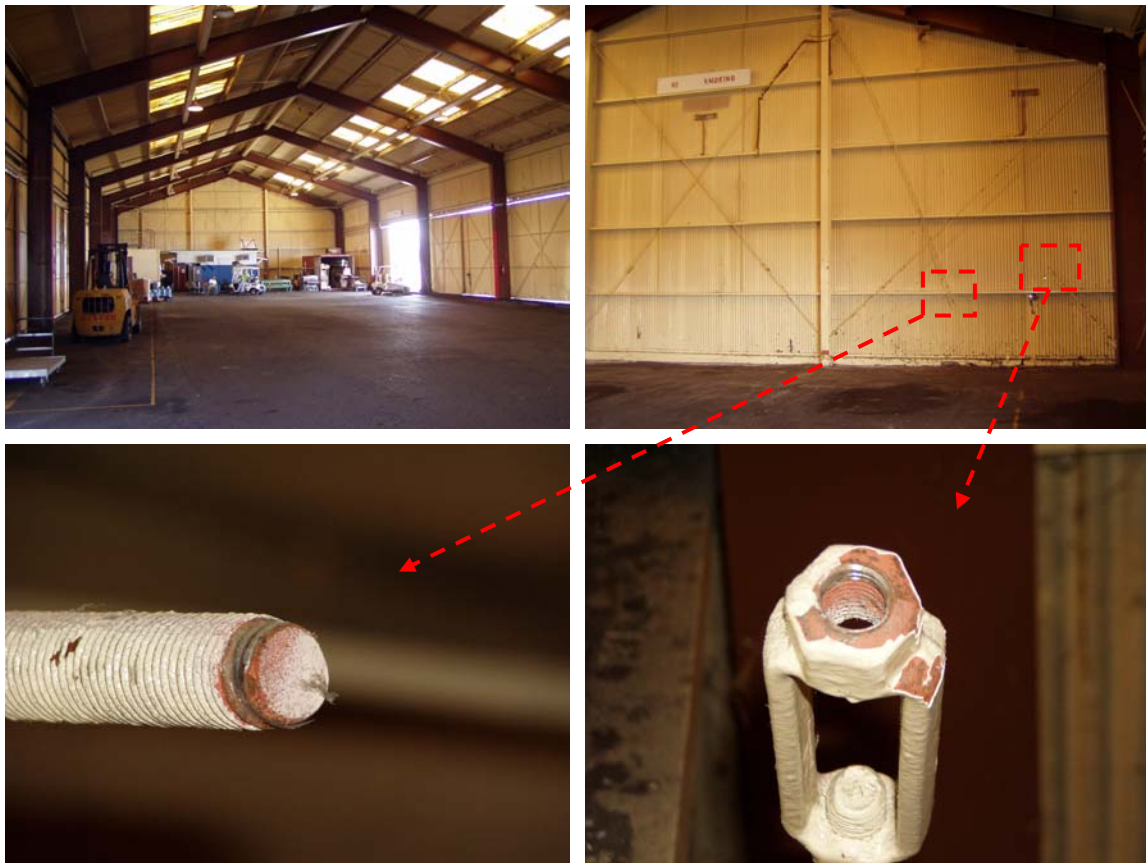
The warehouse on Pier 2 did not appear to be adversely affected by the lateral spreading, however, one diagonal brace member had separated at the adjustment turnbuckle as shown in Figure 47. It appeared that only two threads of the bracing rod had been engaged with the turnbuckle, resulting in stripping of these threads during the ground shaking.

Figure 47: Failed diagonal brace at North end wall of warehouse on Kawaihae Harbor Pier 2 (H1).

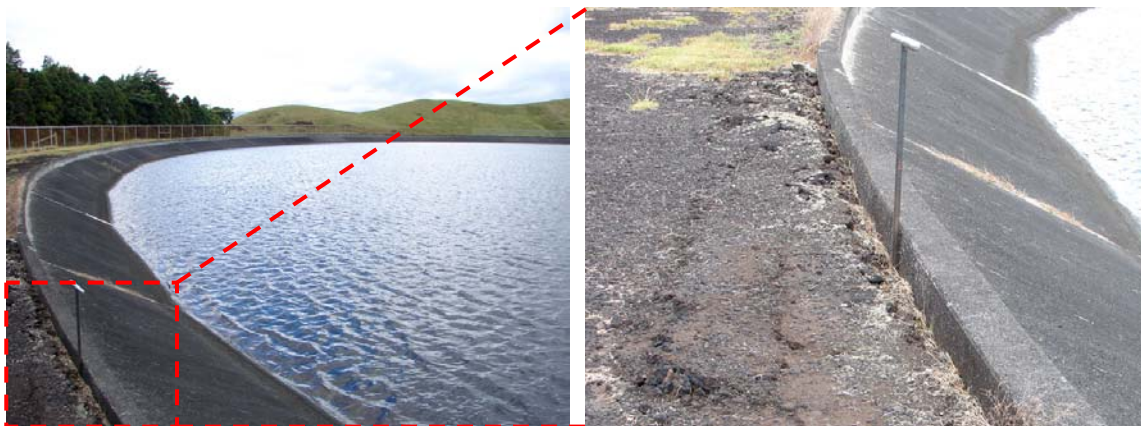
Figure 48: Waikoloa II reservoir showing lateral displacement of top of embankment (D1).

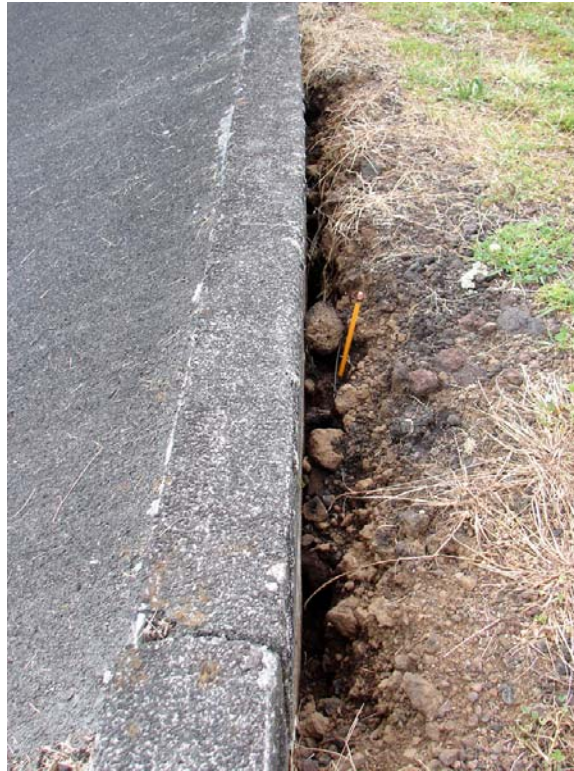
Figure 49: Cracks on top of embankment adjacent to concrete liner panels (D1).
